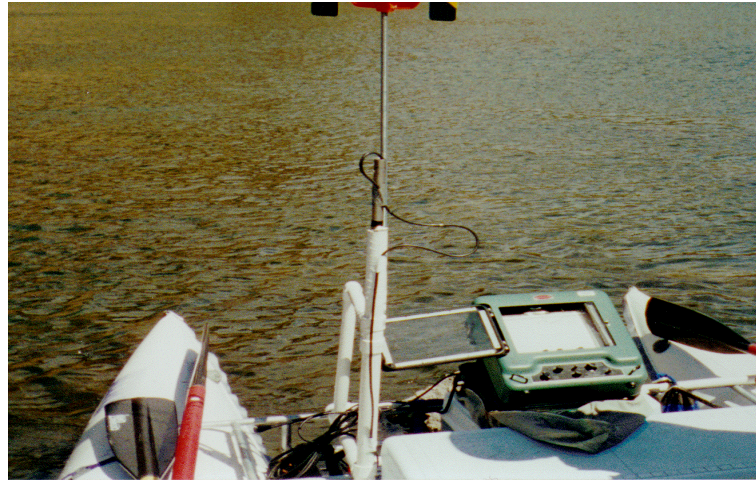
*Photograph A- 13. Hydrographic surveys of the channel bottom were completed along portions of the Teton River in the former reservoir area (about 15 miles upstream of the dam site) using a survey raft equipped to measure water depths. USBR photograph by Tim Randle, 1997.*

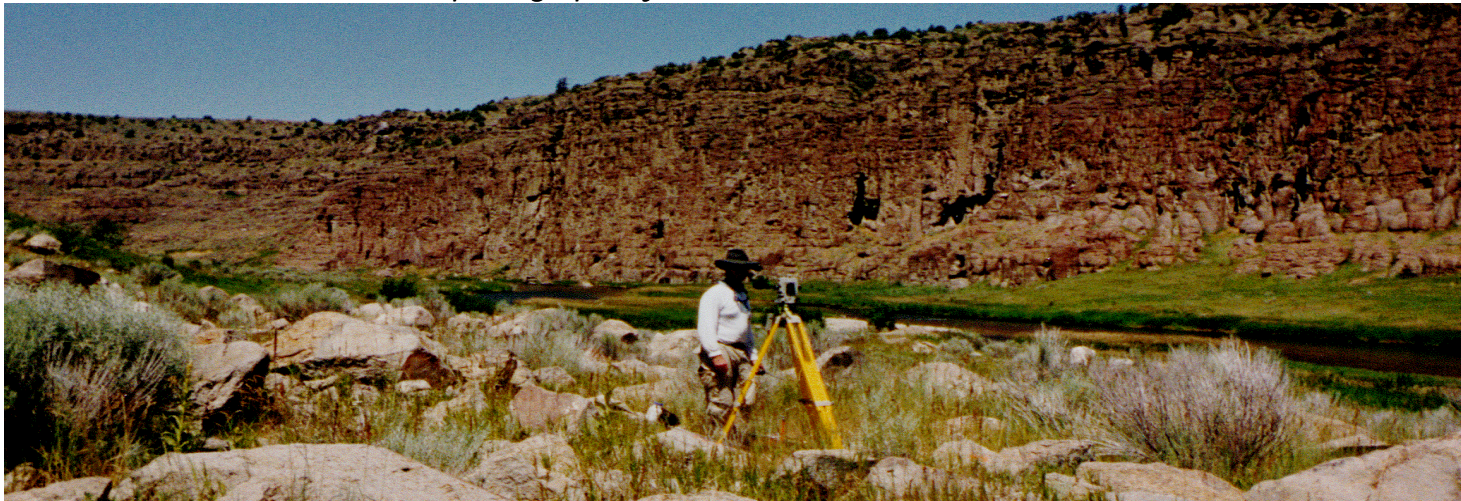
*Photograph A- 14. A total station survey instrument was used to track and measure the horizontal and vertical position of the survey raft. USBR photograph by Jennifer Bountry, 1998.*
